MTL TR 90-25

ANALYSIS OF DATA AND EXAMINATION OF WORN PADS FROM TECOM T-142 TRACK PAD TEST

May 1990

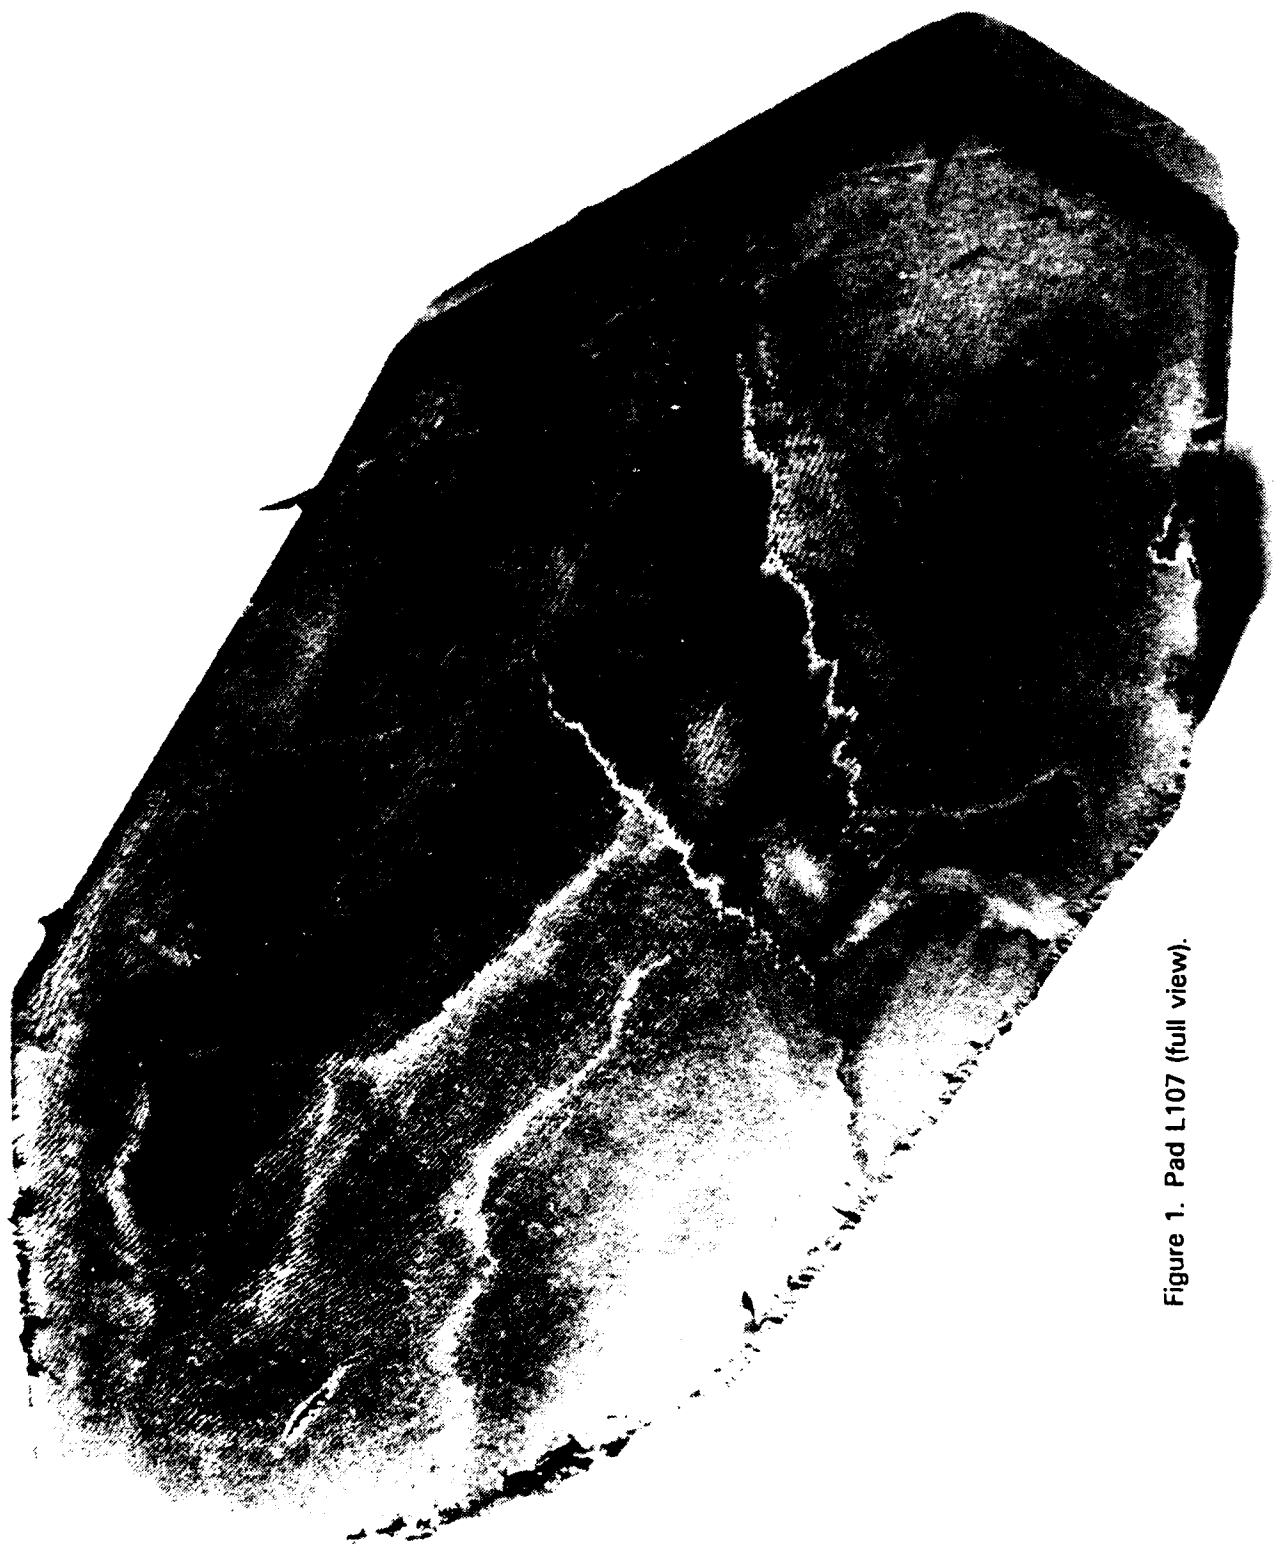
Figure 1. Pad L107 (full view).

Of greatest interest is the finding that wear on the paved road is generally characterized by the development of an abrasion pattern (i.e., a series of ridges running transversely to the direction of wear). A medium-coarse pattern can be seen in the photograph of the entire Pad L107 (Figure 1). To show greater detail, selected regions of three pads, as diagrammed in Figure 2, were photographed using a macro lens (Figures 3 through 5). The ridges run approximately parallel to one another but with some wandering and splitting. The spacing between ridges is clearly greater in Figure 3 (L107) than in Figure 4 (G105). However, it is difficult to obtain a precise estimate of the ridge spacing from examination of the photographs. Also, the photographs give no indication of the height of the ridges (or depth of the grooves). These aspects are discussed in detail in the next section.

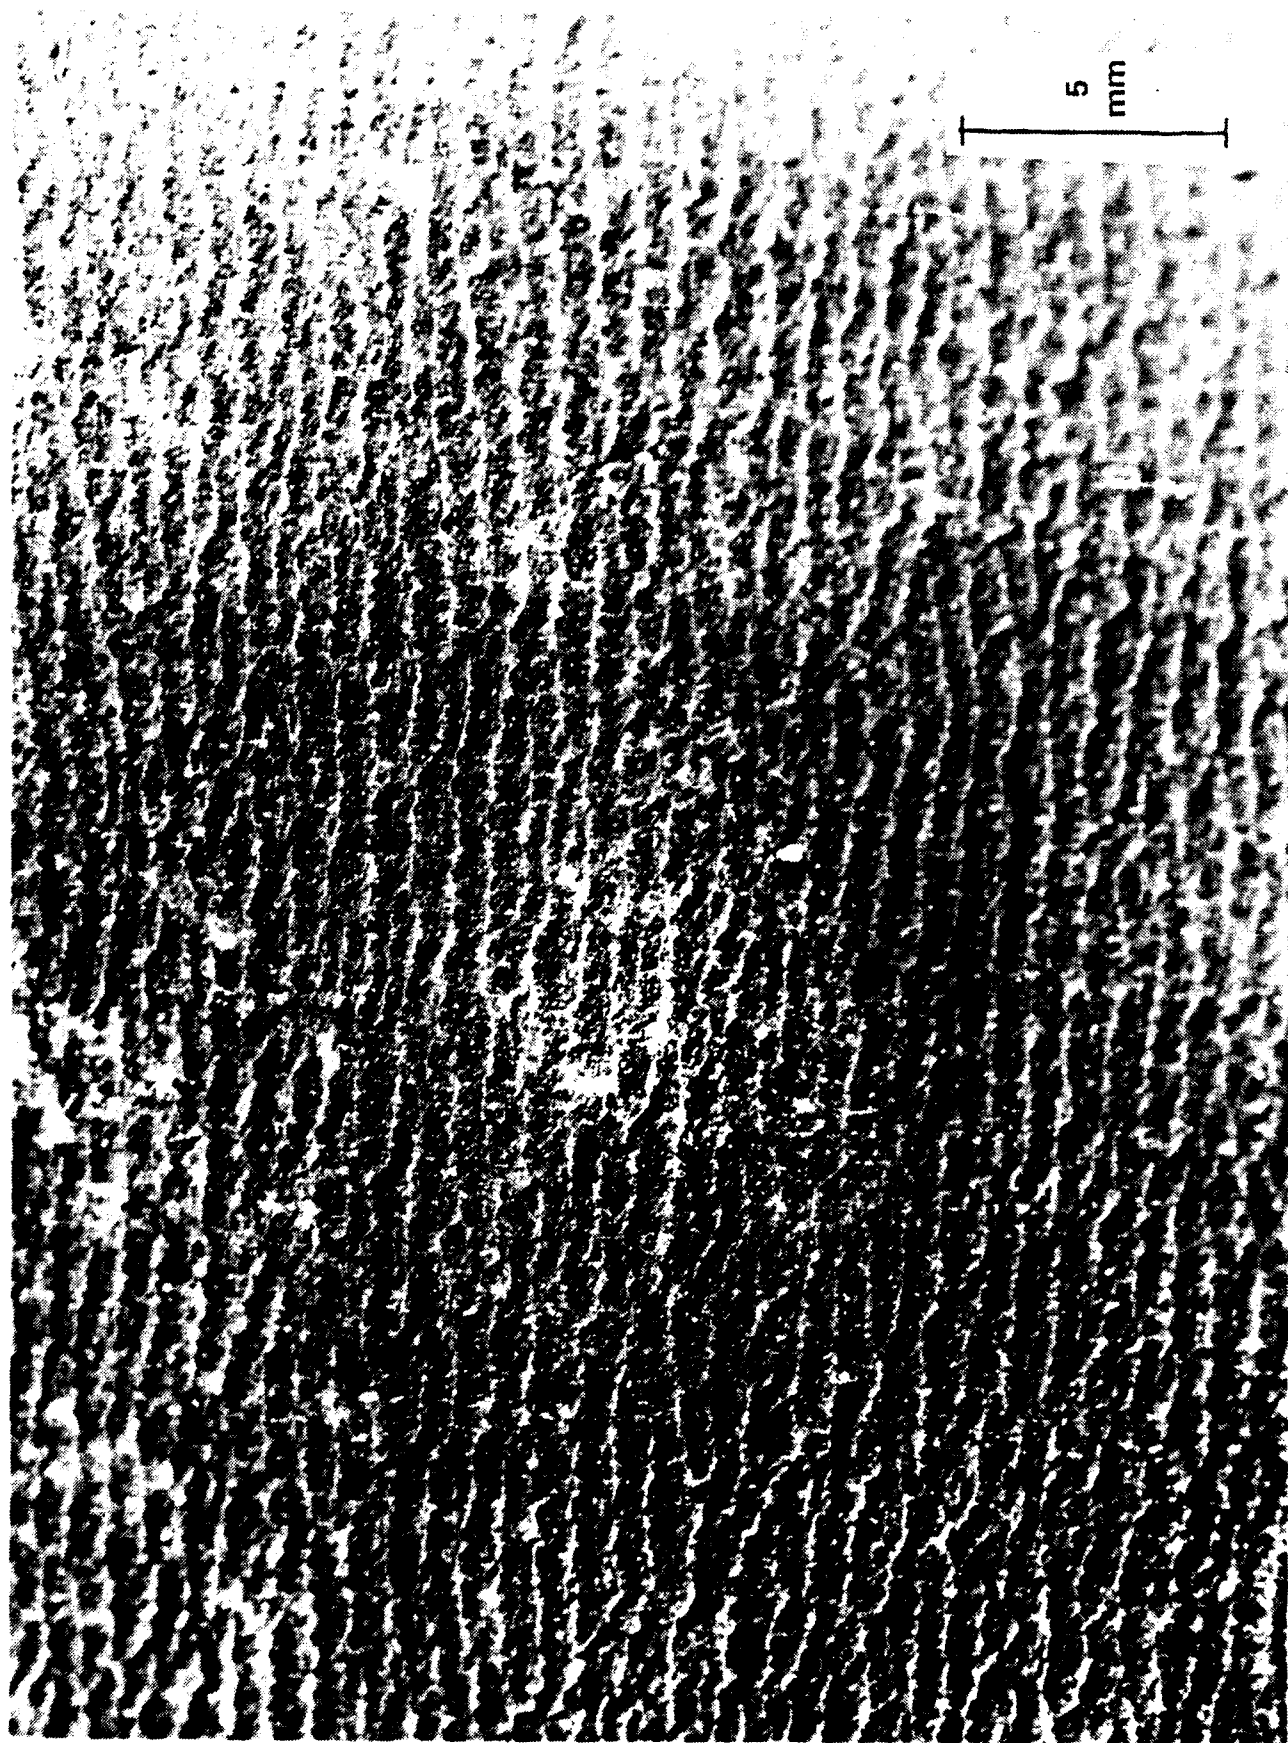
Figure 3. Pad L107 (enlargement of region A).

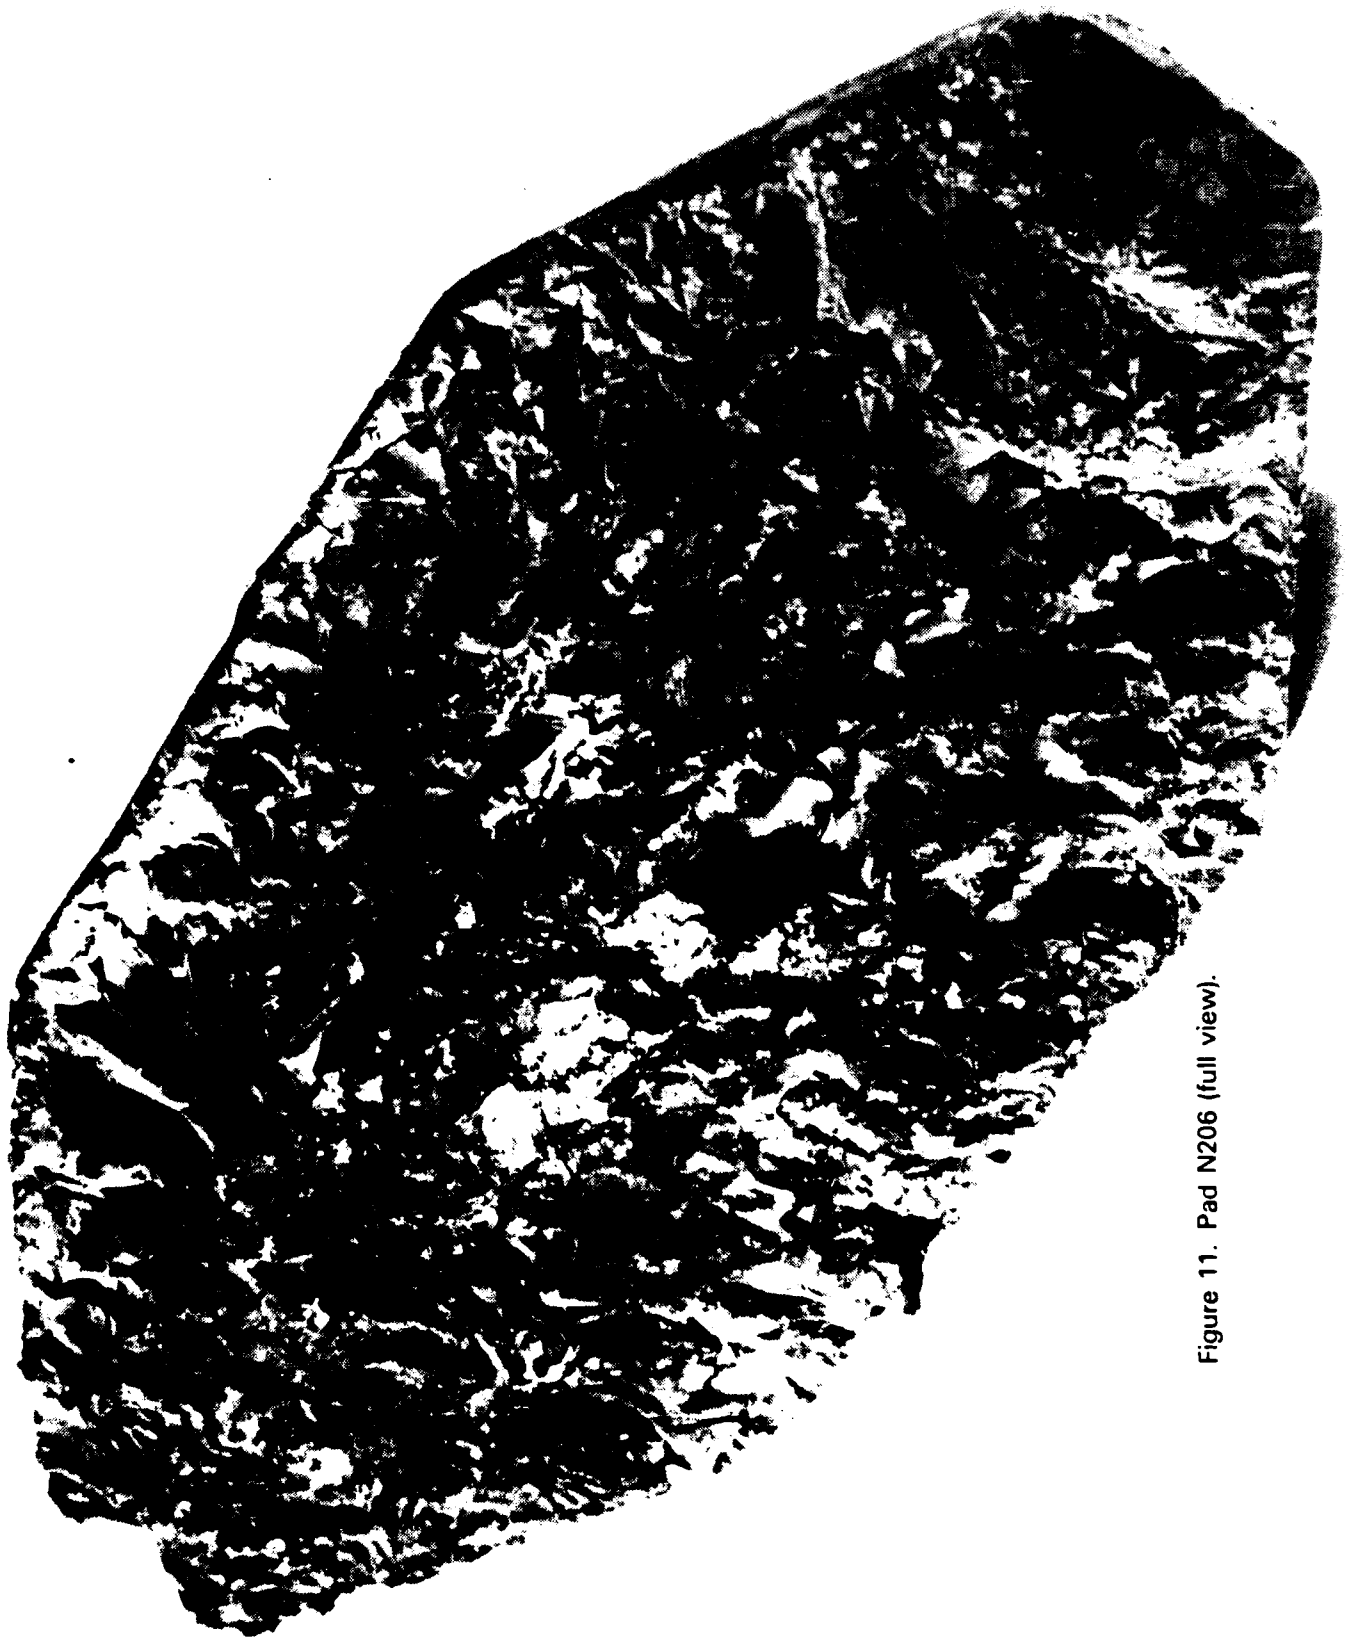
On the HCC course, the observations made generally agree with those given in the field report (i.e., extensive chunking was found under these conditions of wear). Figure 11 (Pad N206) shows coarse, sharp chunking; while in Figure 12 (Pad J209), several regions of the pad appear to have been somewhat smoothed out. Removal of a flap, already shown in the H series on paved road, is illustrated for Pad H209 on the hilly cross-country course (Figure 13). It is remarkable that a few compounds (A and B) show some pattern development as well as chunking (by visual observation).

Figure 11. Pad N206 (full view).

M306	2000	same as M301.
M310	2000	same as M301.
M313	1500	same as M301.
N102	2387	medium-fine pattern thin fin.
N106	2186	fine pattern.
N107	2000	fine pattern.
N116	476	medium pattern; plate cracked; 1/2 of plate loose.
N206	900	extensive coarse chunking.
N207	900	same as N206.
N208	900	same as N206.

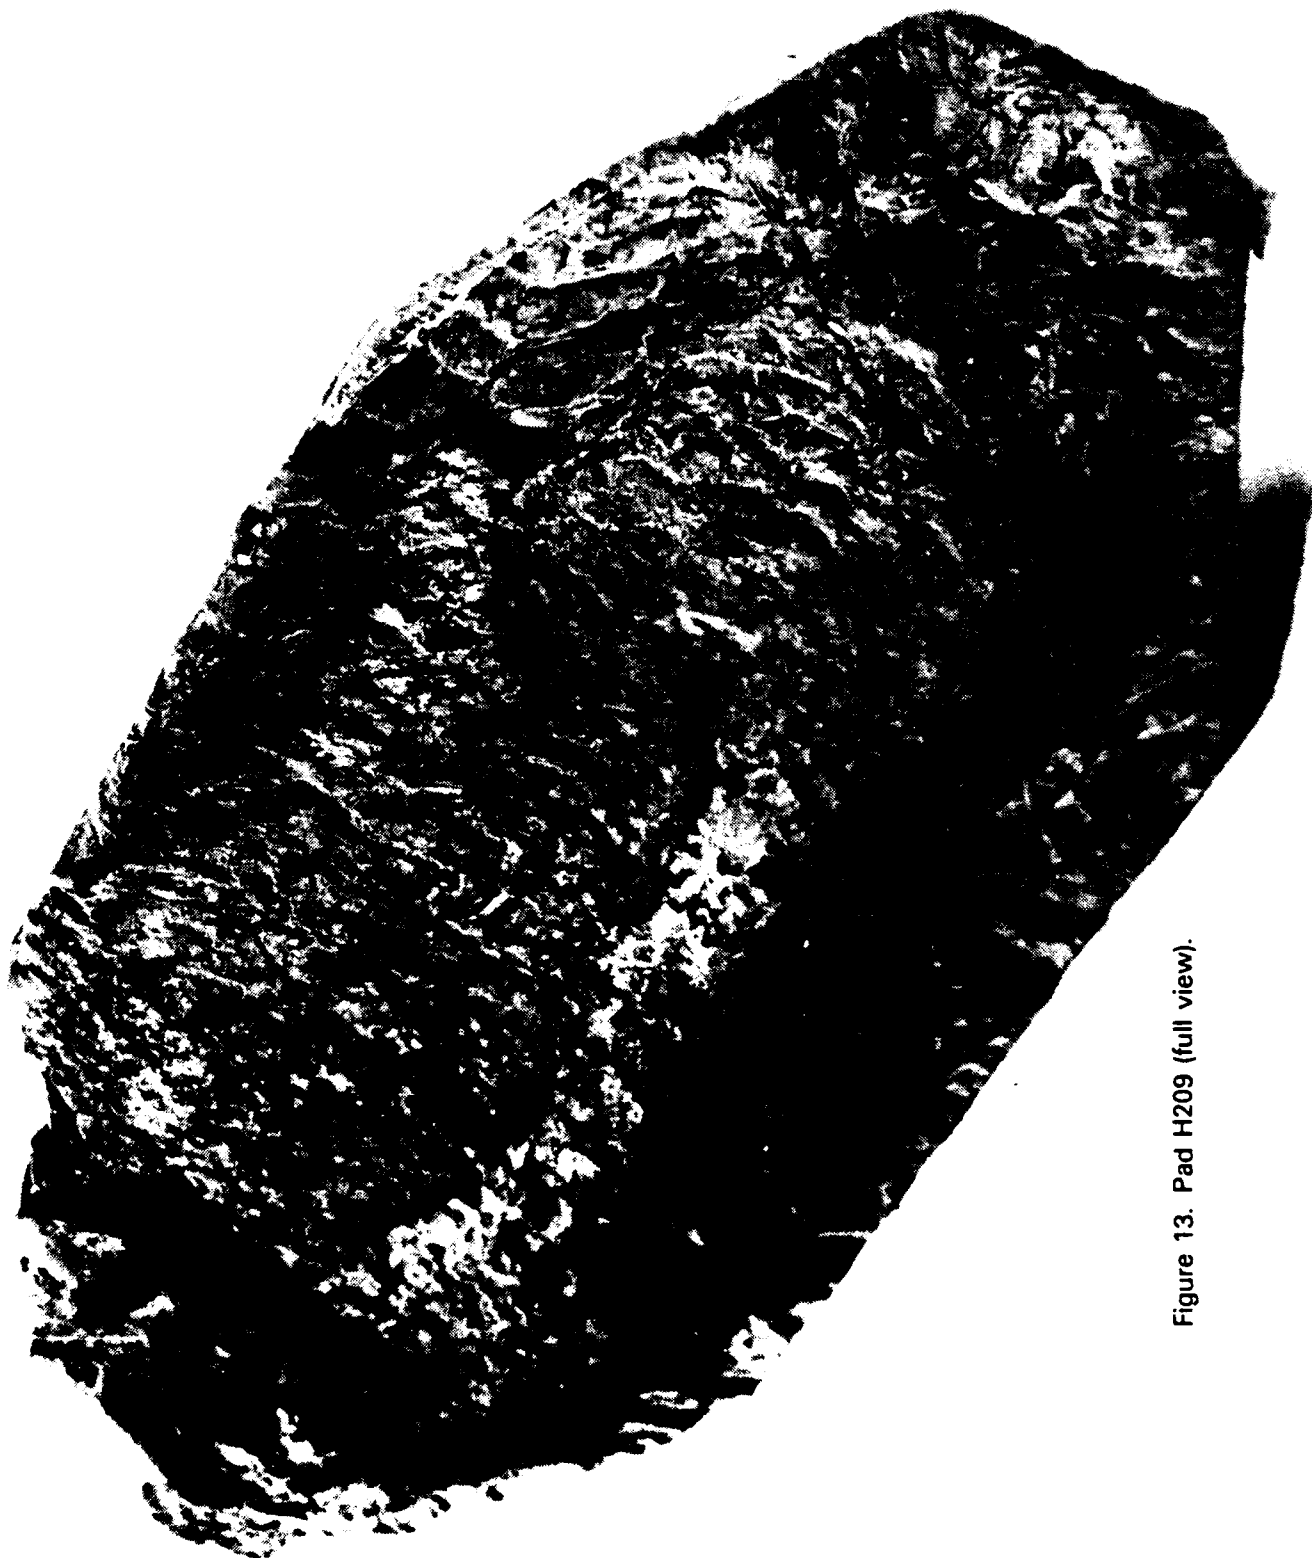
Figure 13. Pad H209 (full view).

H114	3000	same as H113; very fine pattern overall.
H115	1724	pocket flap has gone, 7 inches wide by 3-1/2 inches; smooth surface over 1/2 near leading edge.
H208	780	7-1/2 inch by 3-1/2 inch pocket, flap gone; rough surface.
H209	1076	similar to H208 but worn to backing plate in two spots.
H210	708	missing.
I107	1500	medium pattern throughout; series of cracks near trailing edge; small chunks near one end and leading edge.
I204	900	extensive chunking.
I205	626	extensive chunking.

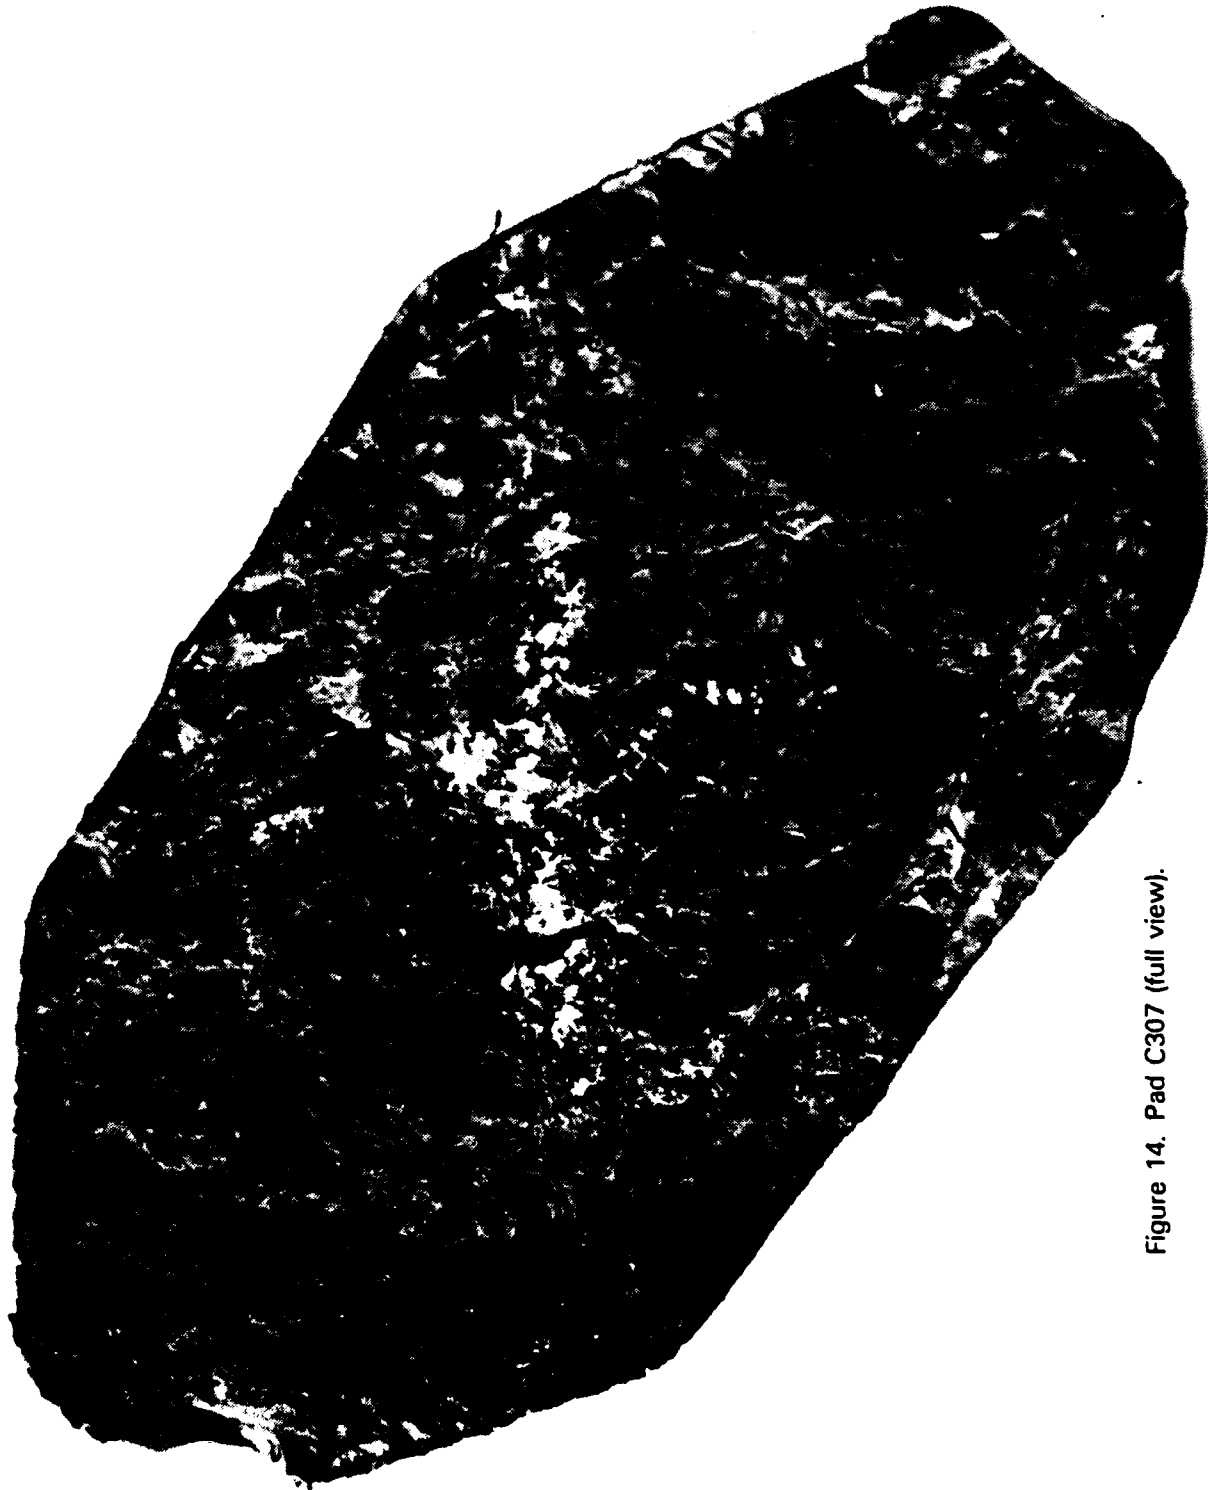
Only a few pads from the combination course were examined. These all showed extensive chunking (Figure 14), presumably occurring during the cross-country segments of this course. A pad which had been run on the combination course (P308) showed a pattern as well as chunking, not surprisingly since it had been run alternately under conditions conducive to both types of wear.

Figure 14. Pad C307 (full view).
